Some items here that may be of some interest, although principally nothing new to the case.

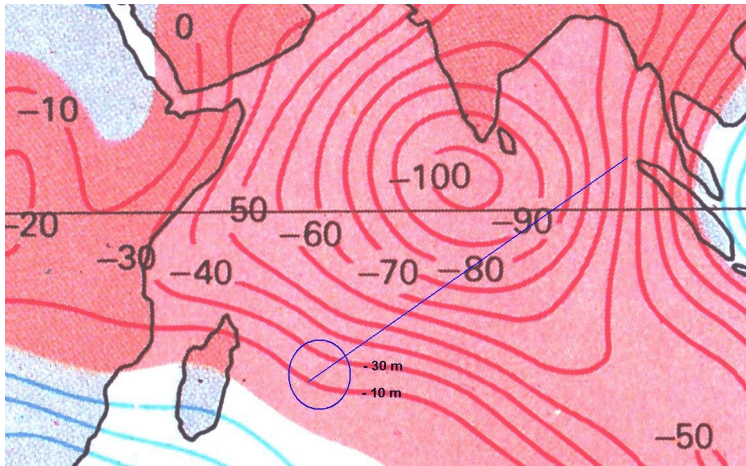
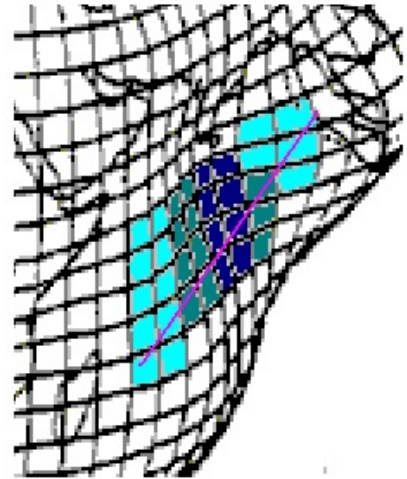
In that particular area, looking from the island towards NE, the earth is not evenly shaped, but has a considerable inward dent. The difference between the island and a location to the SW of Sri Lanka is about 90 metres, which is the max. indent in that part of the globe.

For an a/c approaching the island from the NE, the significant 'drop' of the horizon would be about 20 metres. In other words, to a given ground station antenna height, about 20 metres can be added. As a consequence of this, an a/c in that area may actually be lower than calculated by standard formulae, and still be in line-of-sight with a station on MRU.

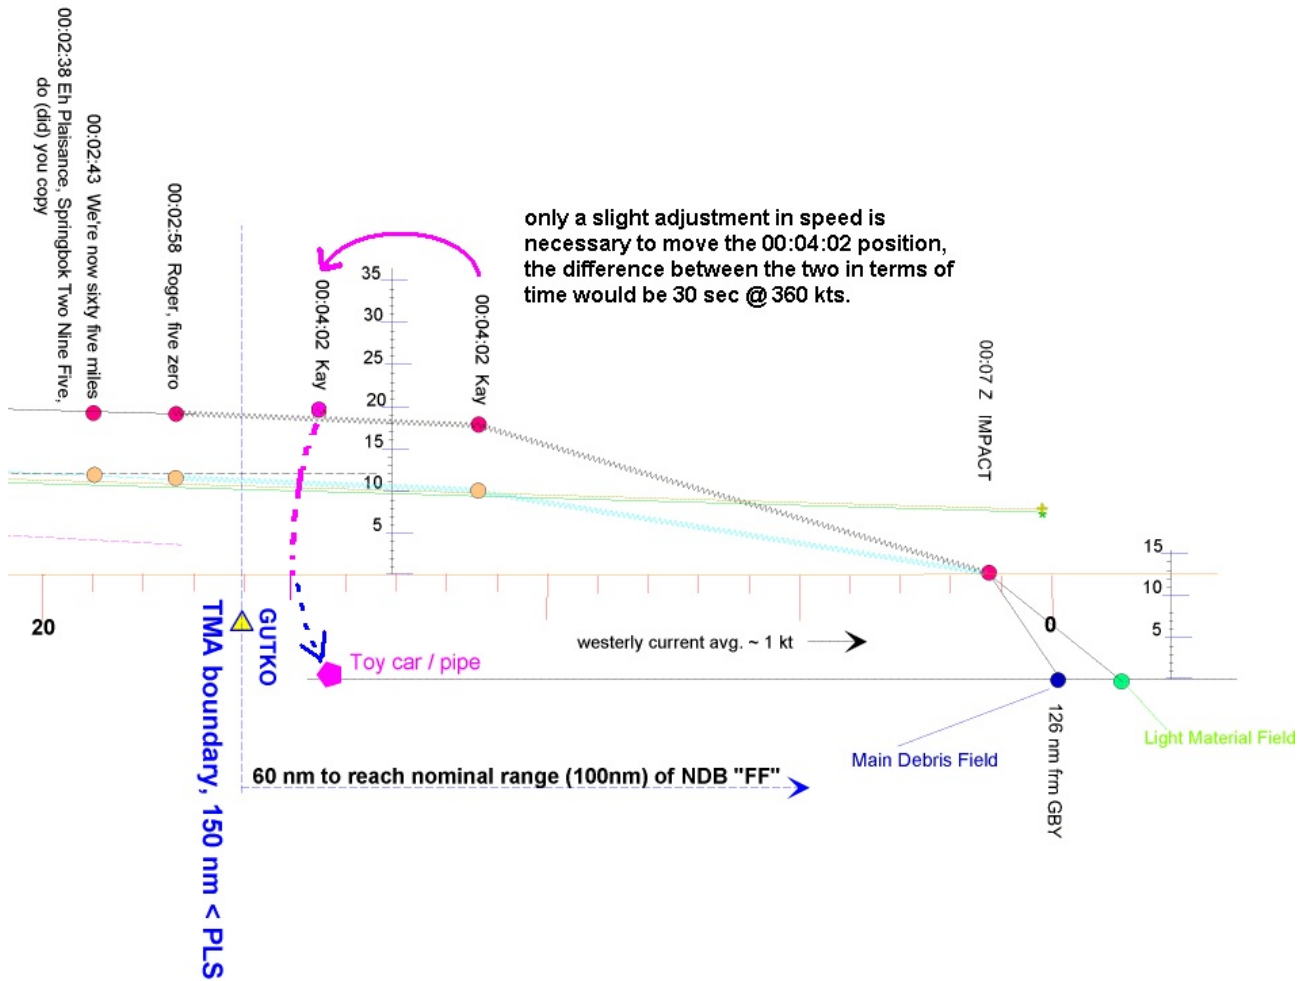
After reading through reports covering TWA800, PA103, AI182, UA811, where it is argued that, the starboard forward lower cargo door opened in flight, I am becoming more and more convinced that, this happened here also. The locking mechanism activated either by faulty wiring plus water; it was raining, foggy at CKS, tarpaulin over pallet; certainly a high relative humidity, which later dripped as condensate on wires into the bilge; or the electrical system, damaged by the fire going wild for a few seconds before going dead.

"We have lost all electrics...", although there must have been some power available until 00:04:02 Z (Kay), and at that time the door could have burst open.

The consequence of such an explosive decompression would be:  
 the cargo door or parts of it detach, followed by parts of a cargo pallet or cargo, and damage engine No.3, loss of power on the starboard side;  
 possible damage to the leading edge of wing, loss of lift on the starboard side,  
 a/c turning and roll to starboard, right wing down, pipe(s) from engine No.3 ripped off,  
 rupture of fuel pipes, hydraulic pipes, loss of fuel, hydraulic fluid.

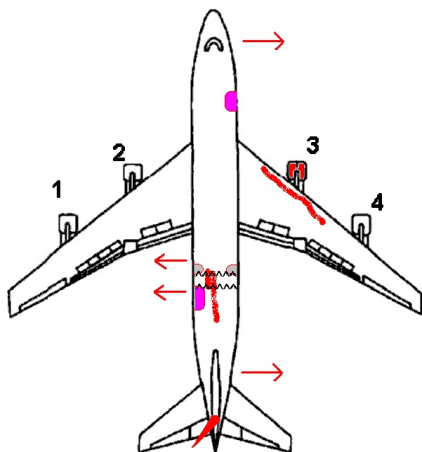
Assuming he was flying manually, an almost instinctive counter action, rudder (full) left, would put considerable additional stress on the hull, structurally weakened by doors 4 L & R, plus the cargo door just aft of door 4 L. Add to that any material fatigue caused by the fire, and additional stress due to the shock wave(s) caused by an explosive decompression, plus turning, rolling a/c, then a break-up looks inevitable.

The average speed from that point (00:04:02 Z) until impact about 14 nm further on would be about 270 kts.

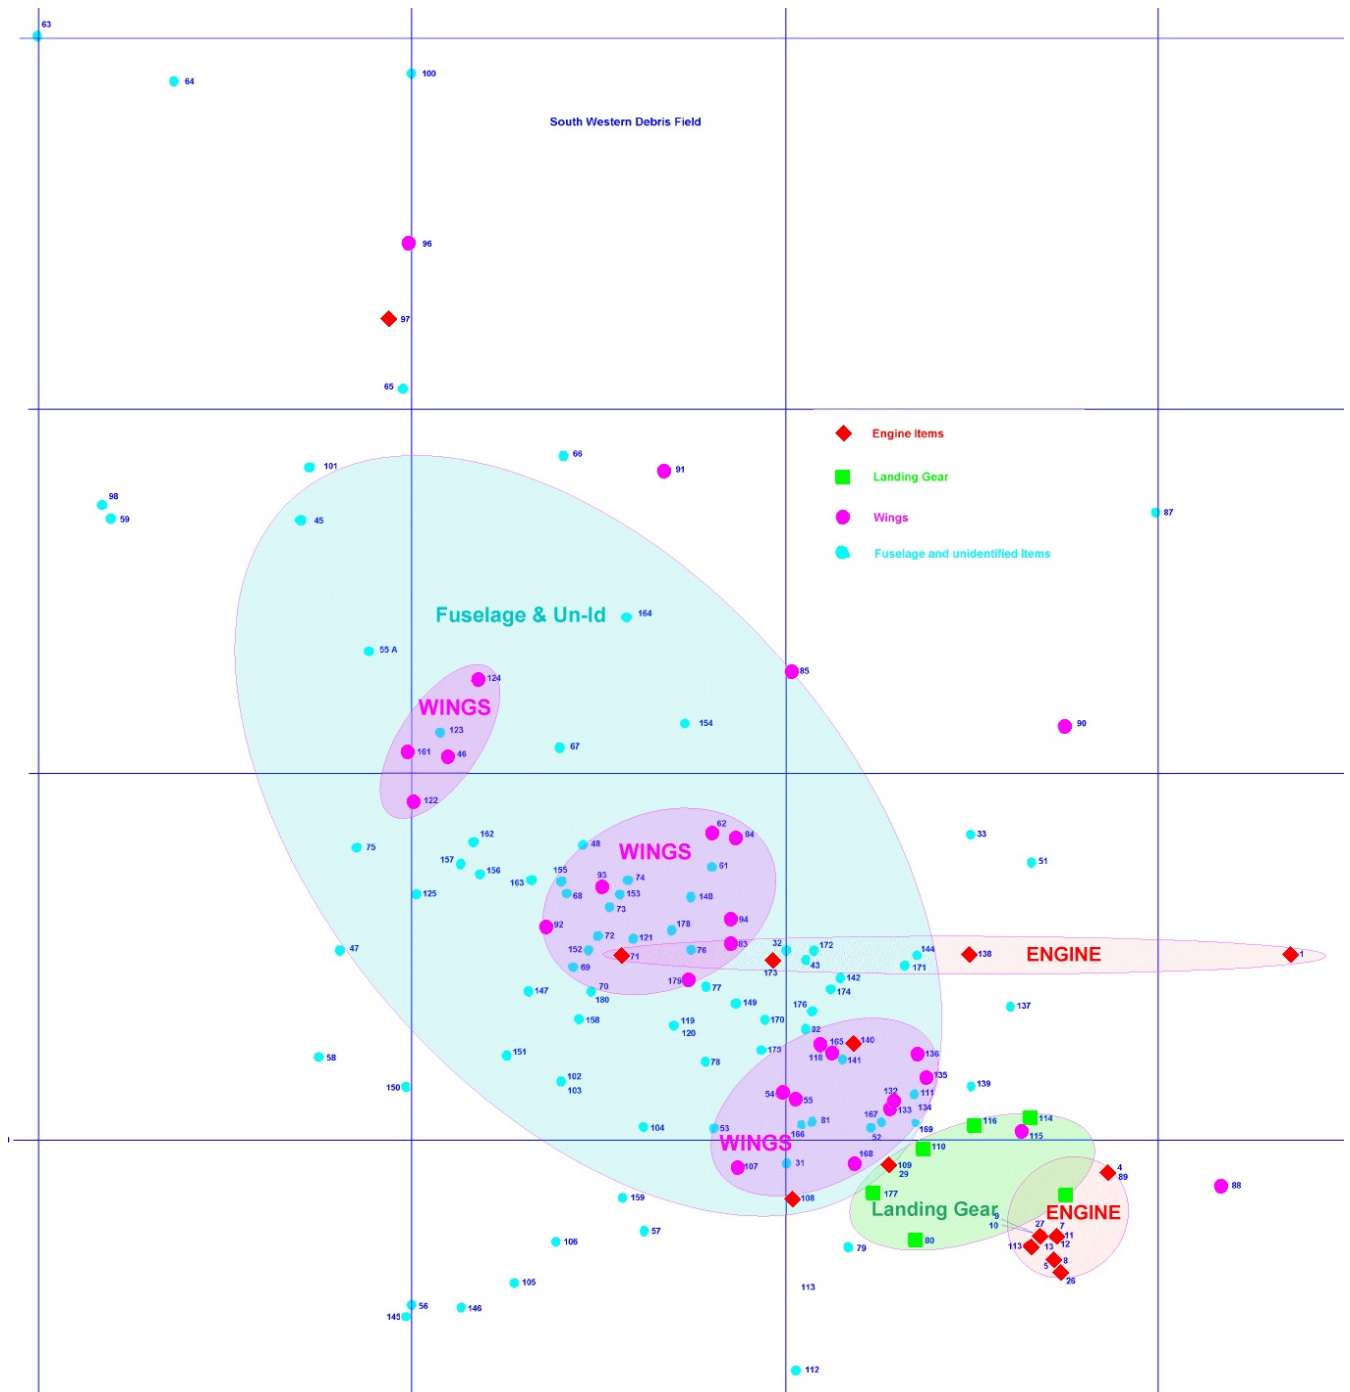
## SW Debris Field

Looking over the diagrams of the debris fields, I found it rather difficult to make something out of it, due to the small size. Only the SW field diagram could be manipulated in such a way as to become 'readable'. A worked-over version is attached. Do you have any idea where the CVR was found? Is this location marked anywhere on the diagrams?

Considering the distribution of debris, it appears plausible that, 1. the plane broke in half shortly before impact, 2. the impact of at least the forward part, (from door 4 forward) happened sideways, starboard side first. Engine and landing gear almost one on top of the other (SW debris field).
