# POOR PERFORMANCE

The Transportation Safety Board of Canada has released its final investigation report into a fatal Boeing 747 cargo crash in Halifax. The findings reveal how a simple error in calculating takeoff performance was a key factor leading to the crash.

*Adapted from the Transportation Safety Board of Canada aviation investigation report number AO4H0004, "Reduced Power at Take-off and Collision with Terrain, MK Airlines Limited, Boeing 747-244SF 9G-MKJ, Halifax International Airport, Nova Scotia, 14 October 2004".*

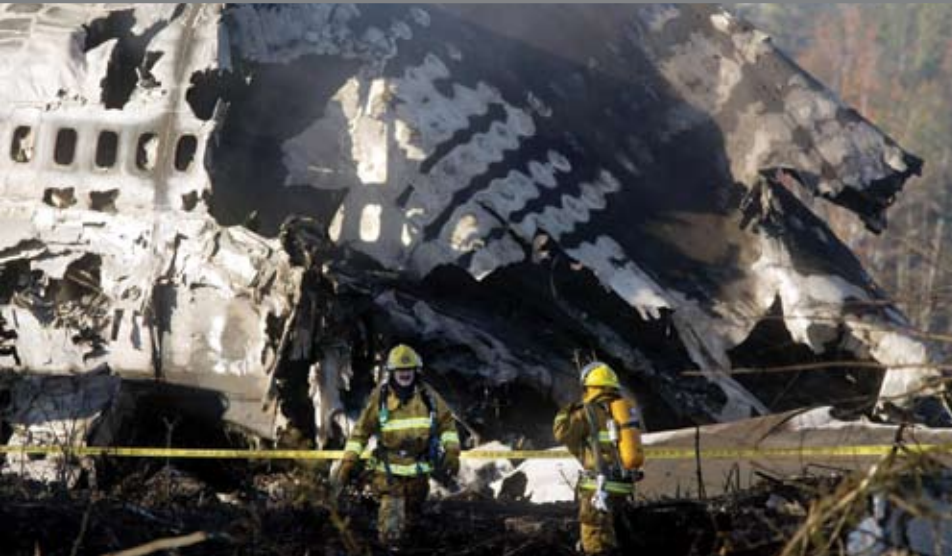
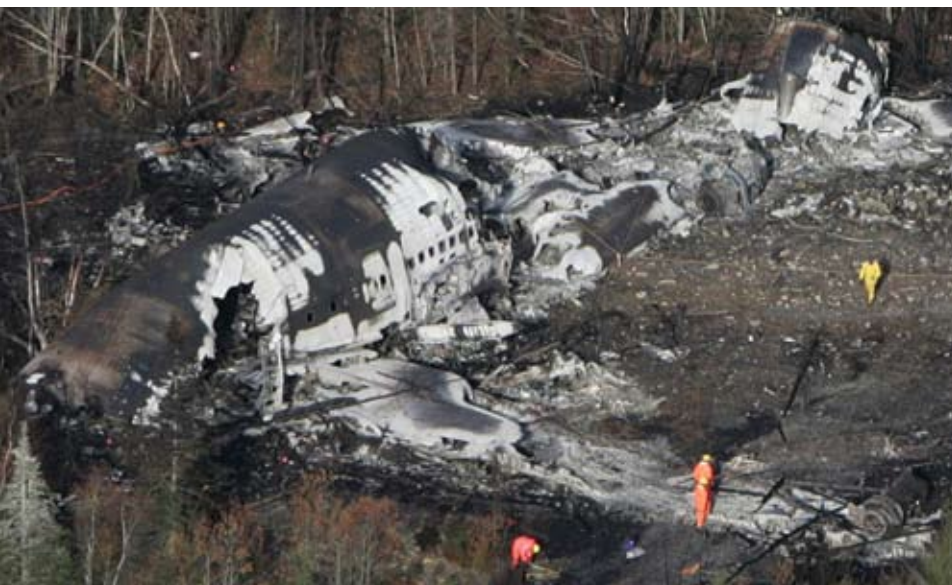
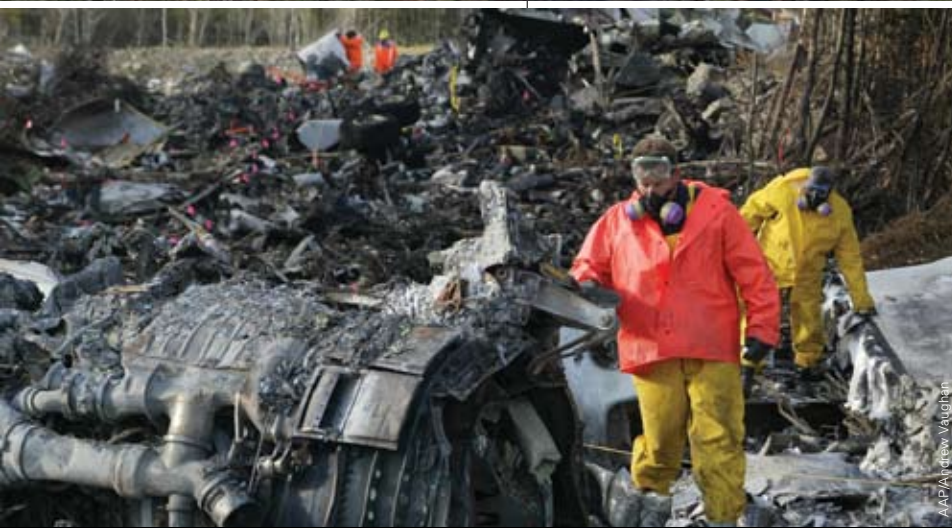
## DISASTER SCENE

**▶ The aircraft ... flew briefly for 325ft before the lower aft fuselage struck an earthen mound supporting an instrument landing system (ILS) localiser antenna, and the tail snapped off.**

**Break up:** Emergency workers look over the broken up remains of Mk Airlines flight 1602 at the accident site near Halifax, Nova Scotia, Canada. Eye witnesses said that the takeoff seemed normal until the last minute when they saw the 747's tail hit the earthen mound supporting the ILS and the aircraft's tail break off.

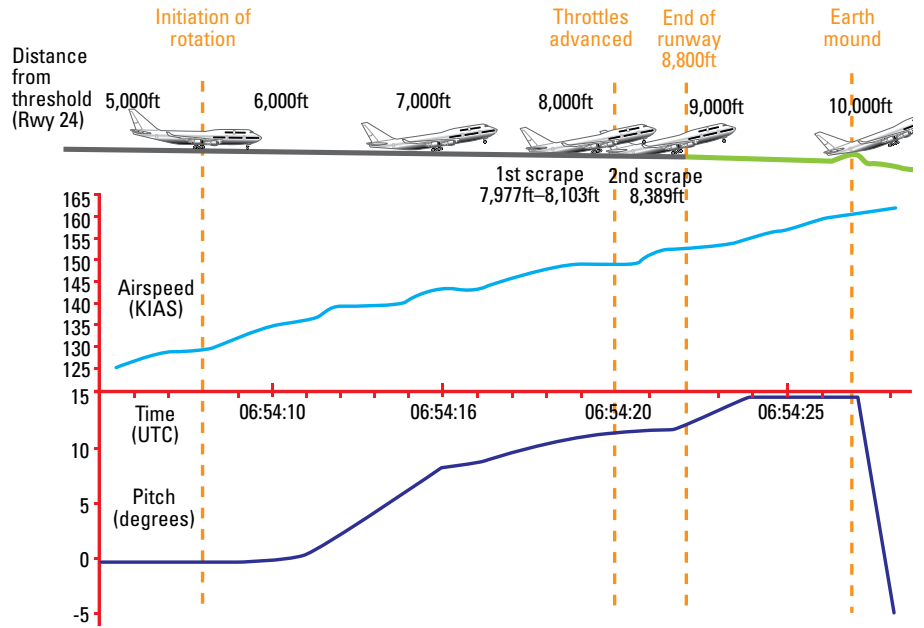
## ACCIDENT SEQUENCE

During rotation, the aircraft's lower aft fuselage briefly contacted the runway. A few seconds later, the aircraft's lower aft fuselage contacted the runway again – this time with considerably more force. The aircraft remained in contact with the ground to a point 825ft beyond the end of the runway, where it became airborne and flew briefly for 325ft before the lower aft fuselage struck an earthen mound supporting an instrument landing system (ILS) localiser antenna and the tail snapped off. The rest of the aircraft continued in the air for another 1,200ft before it hit the ground and burst into flames killing all on board.

**Tail scrape:** The 747's tail scraped the runway twice before the aircraft hit an earth mound at the end of the runway after failing to achieve takeoff performance.

- 6 The aircraft's lower aft fuselage struck an earthen mound supporting a localiser antenna, resulting in the tail separating from the aircraft.
- 7 The company did not have a formal training and testing program for the Boeing laptop computer, and it is likely likely that the user of the laptop was not fully conversant with the software.

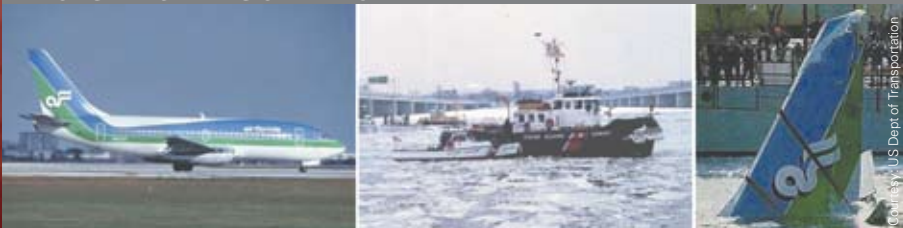
## WRONG EPR SETTING ON TAKEOFF

▶ On January 13, 1982, a Boeing 737-222 was on a scheduled flight from Washington, DC, to Fort Lauderdale, Florida. During takeoff, the engine pressure ratios (EPRs) were set for 2.04, and on the takeoff run, anomalous engine instrument readings were noted; the captain elected to continue the takeoff. Approximately 2,000ft and 15 seconds past the normal takeoff point, the aircraft became airborne. The aircraft initially climbed, but failed to accelerate. The stall warning stick shaker activated shortly after takeoff and continued until the aircraft settled, hit the 14th Street Bridge and several vehicles, then plunged into the frozen Potomac River. The investigation revealed that the engine inlet pressure probes had become blocked with ice, resulting in high EPR indications. Of the 79 persons on board, 74 perished, and there were four ground fatalities.

**Pressure problem:** Ice blocked the engine inlet pressure probes giving the flight crew of Air Florida flight 90 incorrect readings. The 737-222 hit a bridge shortly after takeoff and plunged into Washington's Potomac River. Left to right: the aircraft at Miami, Florida; US coast guard vessels help with recovery; salvage operations begin.
