SNOOKER BALLS AND FLYING BOXES

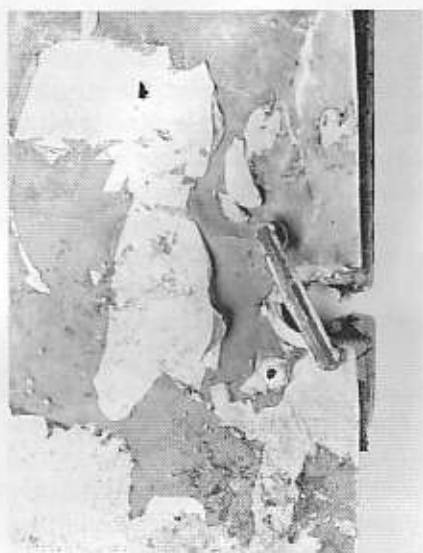
Part of the door leading from the passenger compartment into the main deck cargo compartment. The door was blistered, partly collapsed and splattered with an unidentified blue substance on the cargo compartment side. Crew would have entered the cargo compartment through this door to inspect the fire and attempt to bring it under control
